**Environmental Restoration (ER) Project  
Cerro Grande Fire  
Accelerated Action Information Sheet**

**Potential Release Site (PRS) 02-011(d)  
Building Outfall**

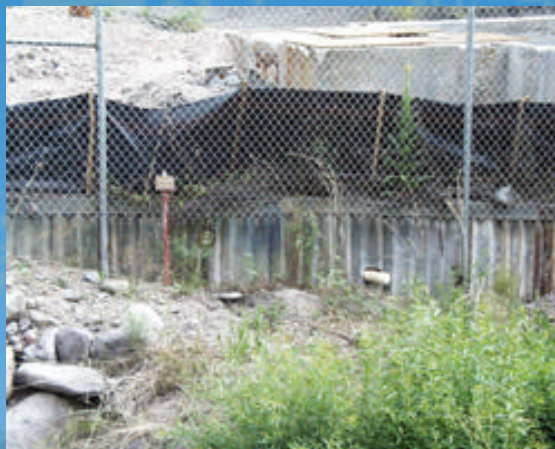
**PRS History:** PRS 02-011(d) is Outfall No. 019, permitted under the National Pollutant Discharge Elimination System. The outfall discharges from a 4-inch vitrified clay pipe (PRS 02-011(c)). The pipe and outfall are likely the route through which liquid effluent from an ion exchange system in Building 2-44 was discharged. Primary cooling water would circulate through this exchange system to remove contaminants. Periodically, these ion exchangers would be regenerated by flushing clean water through them. This flushed effluent water was discharged directly to Los Alamos Creek prior to 1963. From 1963 to 1968, the effluent water was held in three 1200-gallon storage tanks (PRSs 02-004(a), (b), and (c)) until short-lived radioactive constituents decayed or were diluted to a safe level before being pumped into the creek. After 1968, these effluents were transferred to the three 1200-gallon storage tanks and then transported to TA-50 for disposal. High levels of chromium have been found in soils on the creek bank near PRS 02-011(d). The storage tanks were removed in a decontamination and decommissioning action in June 2000.

**Issues of Concern:** The area upstream of PRS 02-011(d) burned during the Cerro Grande fire. The intensity of upstream burn was low to moderate. The site has a surface component, and there is potential for erosion or scouring. The site has no debris that could enter the flood watercourse, nor are there any structures that could interfere with or be impacted by flood mitigation measures.

**Accelerated Action Status:** PRS 02-011(d) was evaluated after the Cerro Grande fire. ER Project personnel collected 3 soil samples from below the outfall. The data has not yet been validated or reviewed.
